Manhole Inspection Summary

Manhole # S21O__008MH

Insp Date: **3/14/08 10:39 AM**

Location Address: **2037 s brice-s pulaski alley**

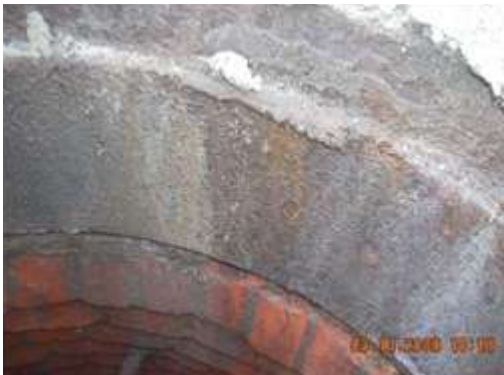
Defect 1

☒ **Leaks**

Infiltration: ☐ None ☐ Joint ☐ Cracks ☐ Mortar ☐ Roots ☒ **Wall**

chimney flow wall

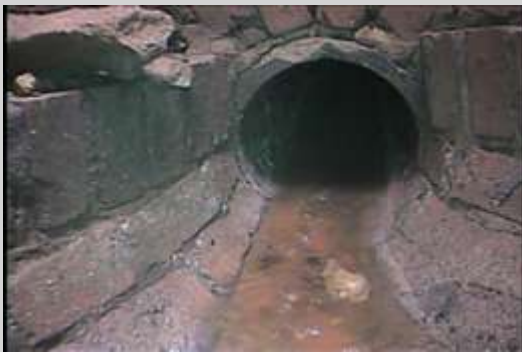
12 O'Clock Outflow

8 in. Circular Gravity Sewer
Pipe Out @ 12 O'Clock

Pipe Height: **8.4** (in.) Rod and Bar (Angled)
Pipe Material: **Clay** ☐ Pipe Lined
Invert Depth: **8.06** (ft.) Flow Characteristics: **Slow**
Deposits: ☒ None ☐ Mud ☐ Sludge ☐ Debris ☐ Grease
Silt Depth: **0** (in.) Deposits Extent:
Infiltration: **None** Pipe Seal Cond: **Cracked**

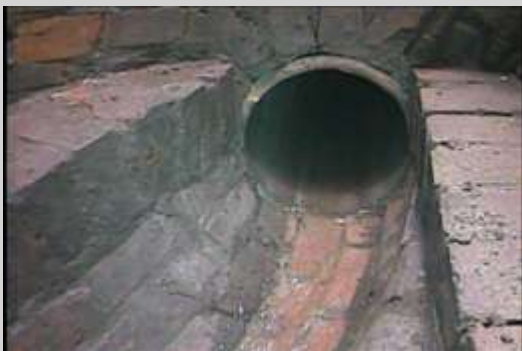
3 O'Clock Inflow

8 in. Circular Gravity Sewer
Pipe In @ 3 O'Clock

Pipe Height: **7.2** (in.) Rod and Bar (Angled)
Pipe Material: **Clay** ☐ Pipe Lined
Invert Depth: **7.59** (ft.) Flow Characteristics: **Slow**
Deposits: ☒ None ☐ Mud ☐ Sludge ☐ Debris ☐ Grease
Silt Depth: **0** (in.) Deposits Extent:
Infiltration: **None** Pipe Seal Cond: **Sound**

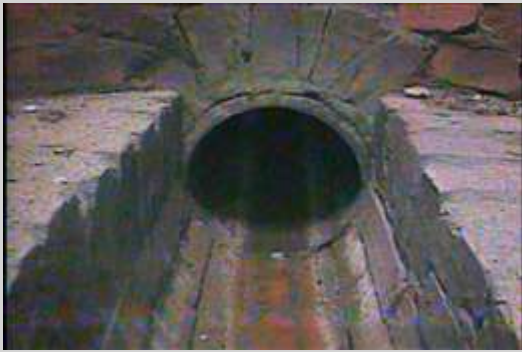
6 O'Clock Inflow

8 in. Circular Gravity Sewer

Pipe In @ 6 O'Clock

Pipe Height: **8.4** (in.) Rod and Bar (Angled)

Infiltration: **None** Pipe Seal Cond: **Sound**

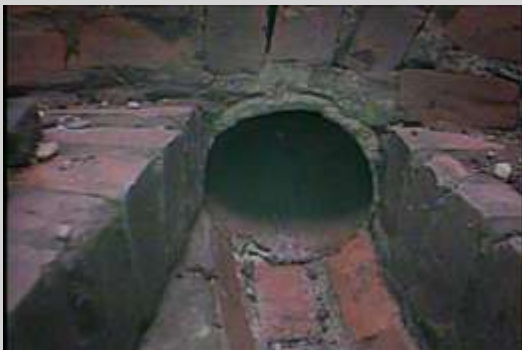
9 O'Clock Inflow

6 in. Circular Gravity Sewer

Pipe In @ 9 O'Clock

Pipe Height: **6** (in.) Rod and Bar (Angled)

Infiltration: **None** Pipe Seal Cond: **Sound**

Connects To: **House connection / Service line**
